Attached is my report on the Manhattan leach project undertaken during the summer of 1973.

The report is primarily historical, and presents details, photographs, and approximate costs of the work performed.

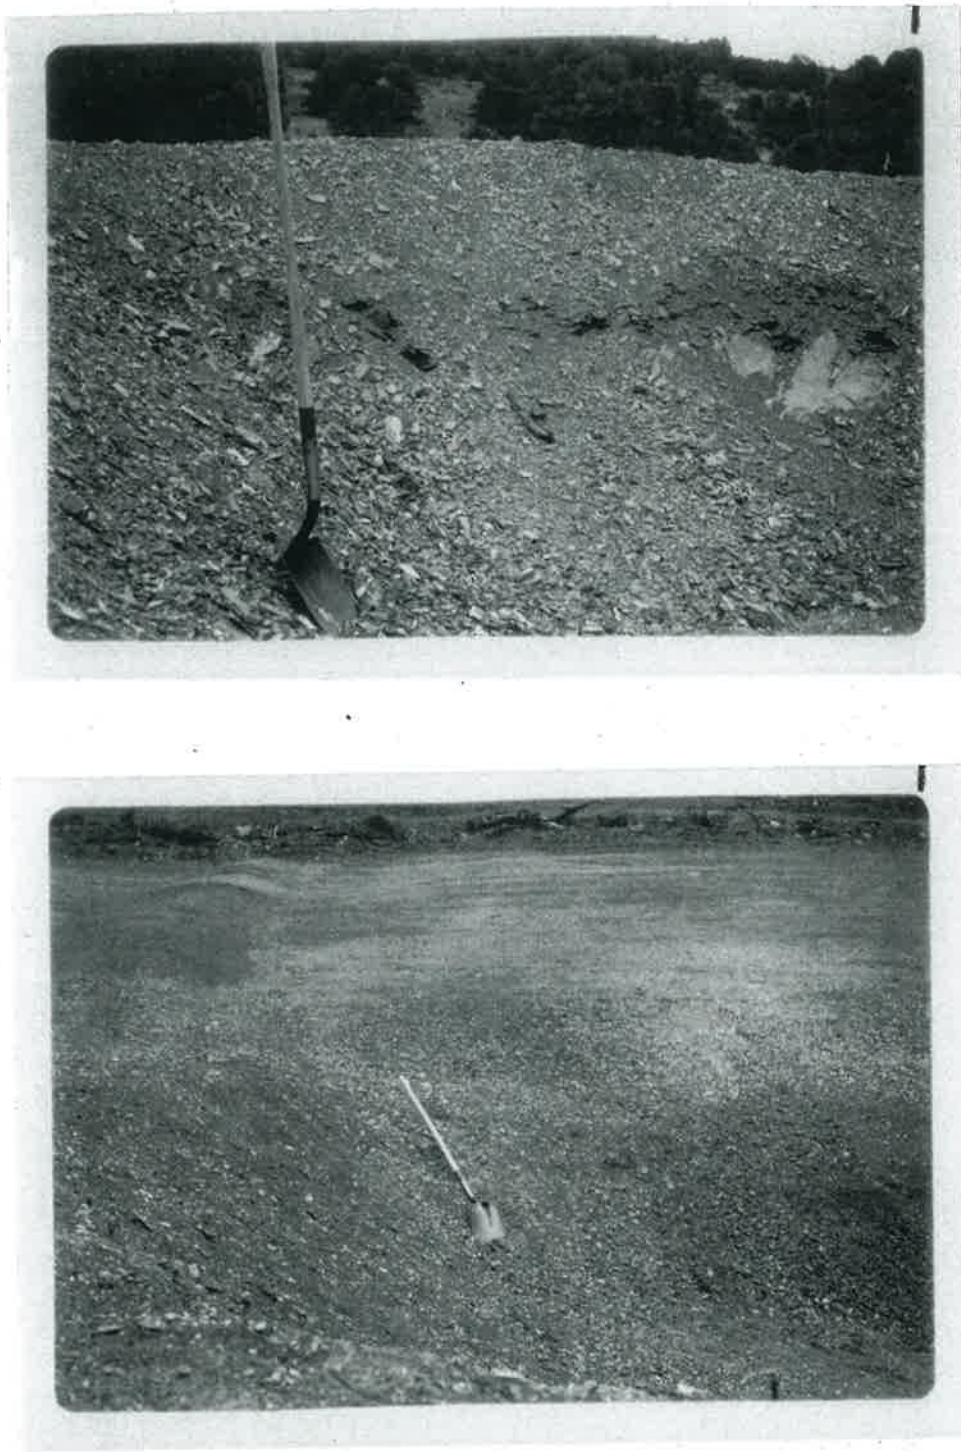
The resulting surface is shown in two views in Figure 4. The surface was firm, with most rock particles less than 3 inches in diameter and few jagged edges. Where the surface steepened to descend into the collecting ponds, bedrock and larger broken pieces were occasionally exposed.

Figure 4. Two views showing the extent of surface preparation prior to laying the pad. The area has been planed to bedrock. Broken rock cover is the result of cutting of the bedrock by grousers on the dozer tracks. Views are at two sites on the small leach pads.

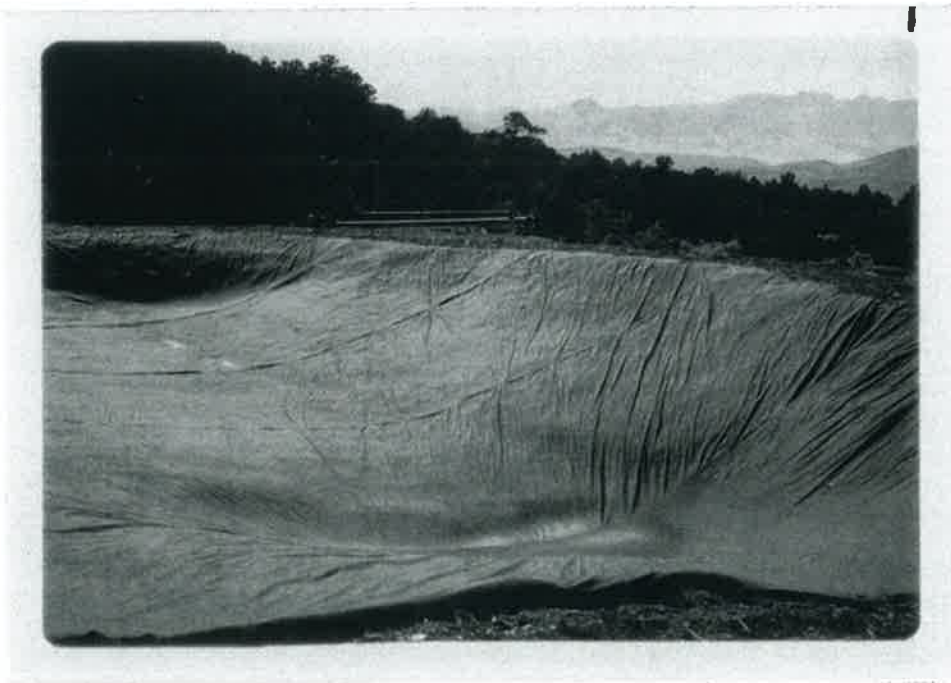
Figure 5. View looking west at the pond for the 5000 ton leach, showing the north berm. This photograph was taken following lining with fabric but before spraying. Rain is responsible for the standing water. The sewn joints can be seen on 15 foot intervals, along with several folds in the cloth which caused some sealing problems. The berm shown, consists of 10 feet of uncompacted fill.

During the week previous to spraying, when the mat was being laid, there were frequent rain showers. These culminated in a heavy rain on August 5 which left the felt mat very damp (in places soaking wet, see Figure 5) when the spraying started on August 6. This was not considered to be a problem.

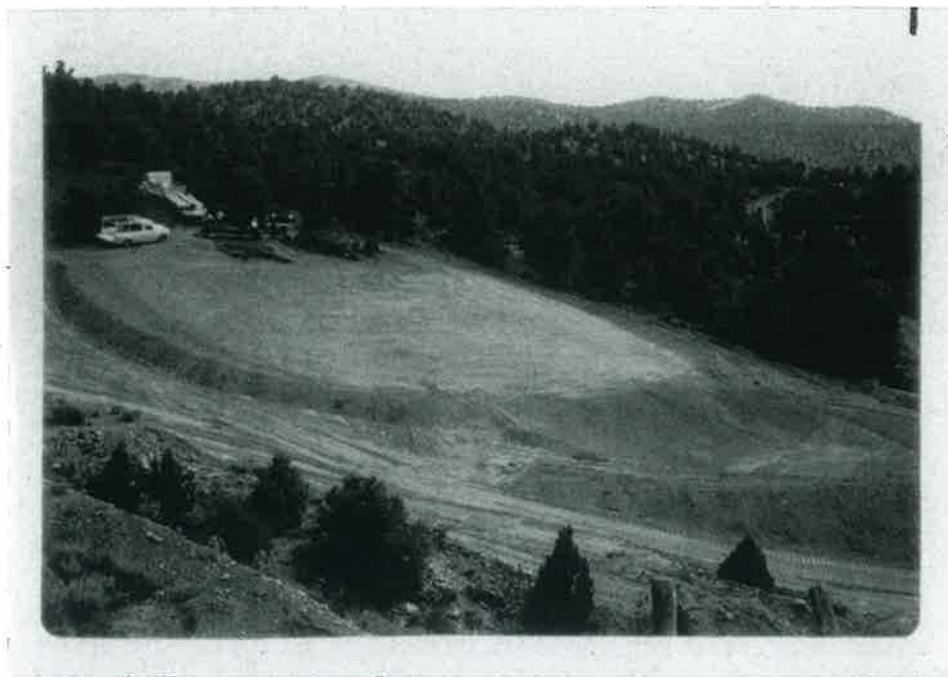
Figure 6. View of the 5000 ton pad area just as mat is starting to be unrolled. Notable features are the pond area with uncompacted berm, and the small uncompacted peripheral berms which direct solutions into the pond. Not so obvious is that the pad area is slightly crowned so solutions flow to the left and right berms as well as straight into the pond. Road at extreme right can be keyed to Figure 3.

Excess material excavated from the pond was used to build a berm around the periphery of the pad, which directs solutions into the pond. In cross-section, this berm resembles a levy with the top about two feet high, and the inner slope nearly flat but sufficiently elevated to cause solutions to run down the berm rather than over the top. The berm was built using a 3/4 yd endloader and was contoured by hand. It was not compacted. A view of the 5000 ton pad showing the pond and berm just before pad placement, is shown in Figure 6. This view is taken from the same location as Figure 3.

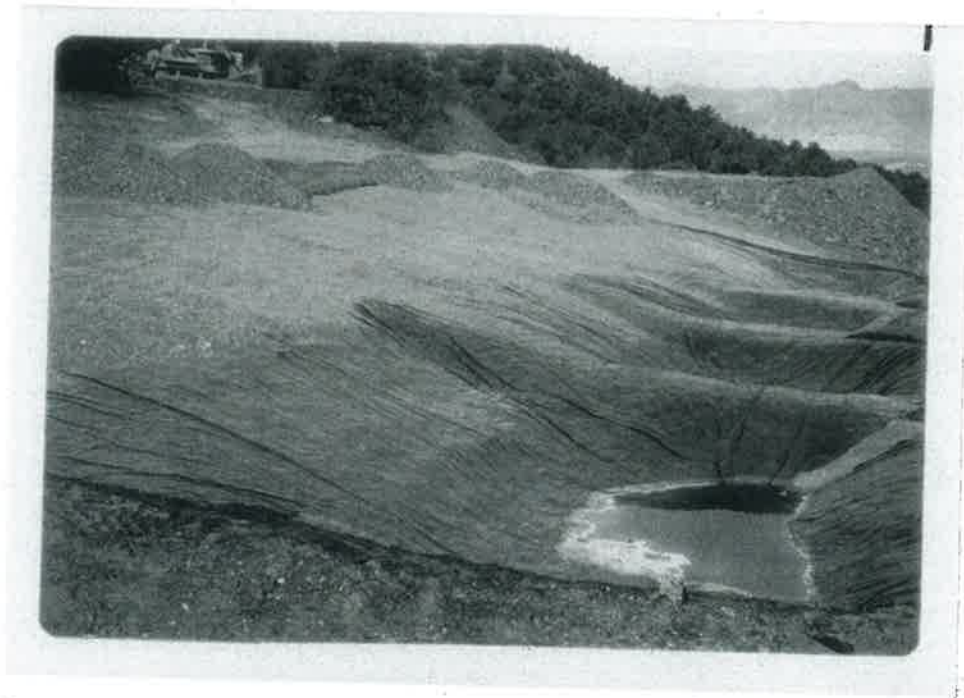
The four 300-ton leaches were placed on a single Petromat surface measuring 160 ft across slope and 70 feet upslope. This area is shown in Figure 7 after lining and partial gravel covering. It is subdivided by two foot high berms, into four 40 by 40 ft pad surfaces, which drain separately into adjacent 40 by 30 ft collecting ponds.

Figure 7. View looking west across the four small pads. The pads have been completed, and a 2" gravel cover has been applied. First and second lifts of the 5000 ton pad are shown in background.

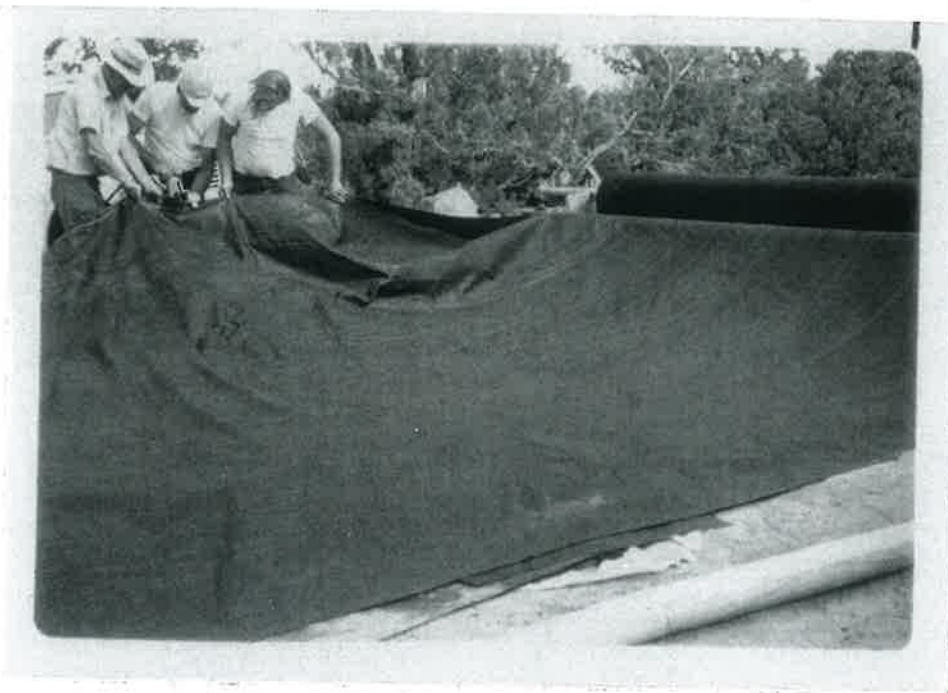
Figure 8. This view shows the 15 ft wide strips of fabric being sewn together as they are unrolled. "Directionality" of the fabric is visible. Greatest tensile strength exists in the long fabric dimension - that is, from left to right in the photo.

As was noted in the caption to Figure 8, the pad material has greater tear resistance in the longitudinal direction than it does transversely. It should be unrolled downslope rather than crossslope to maximize resistance to creep (this was done in the test program).

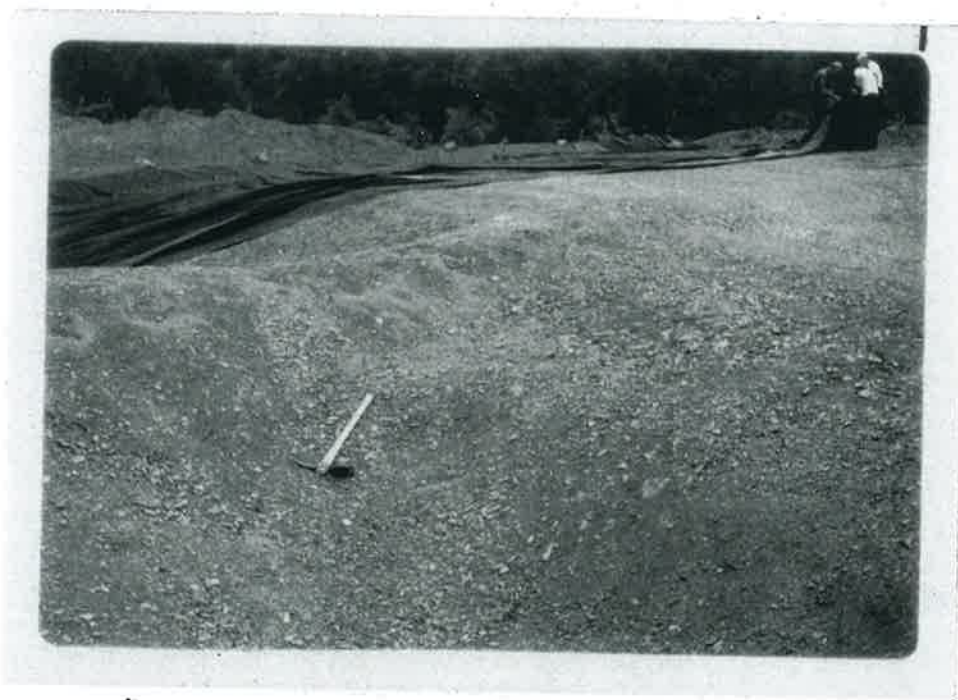
Figure 9. This view shows sewing and fitting of fabric on the small leach pads.

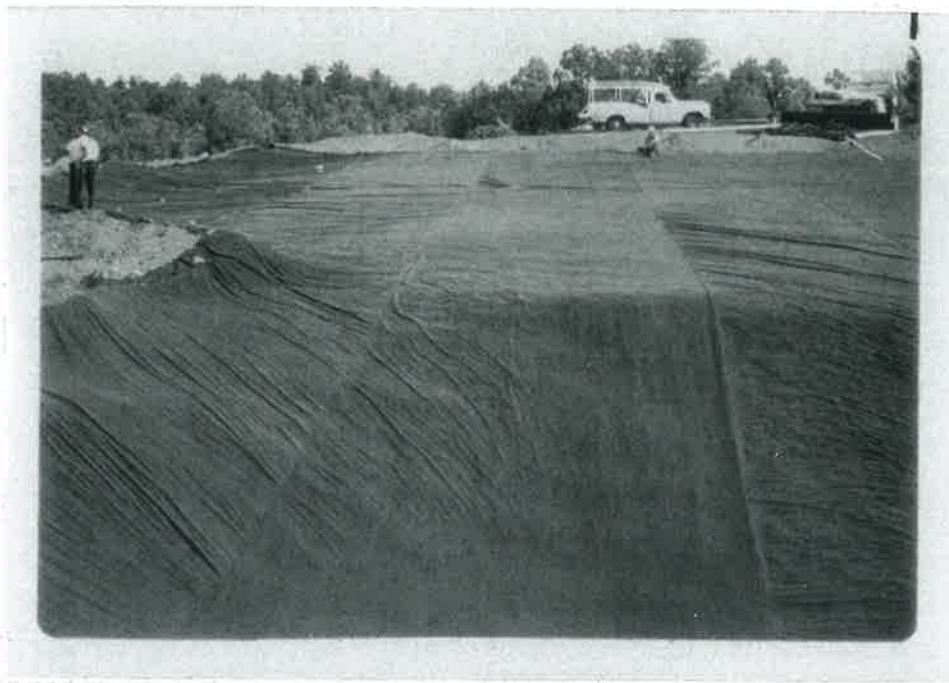
The fabric was laid continuously across the surface, and cut and moulded to fit the contours. Figures 10 and 11 show the fabric in place on the 5000 ton leach, ready for spraying. As can be seen, small wrinkles and folds were left in the material. Where bridging or large folds occurred due to abrupt changes in contours, the fabric was cut and inserts or deletions made. Most seams were sewn on the bottom side so that the top would be a smooth surface.

Figure 10. View looking south, across the pond to the 5000 ton leach pad. The sewn joints and some of the folds are visible.

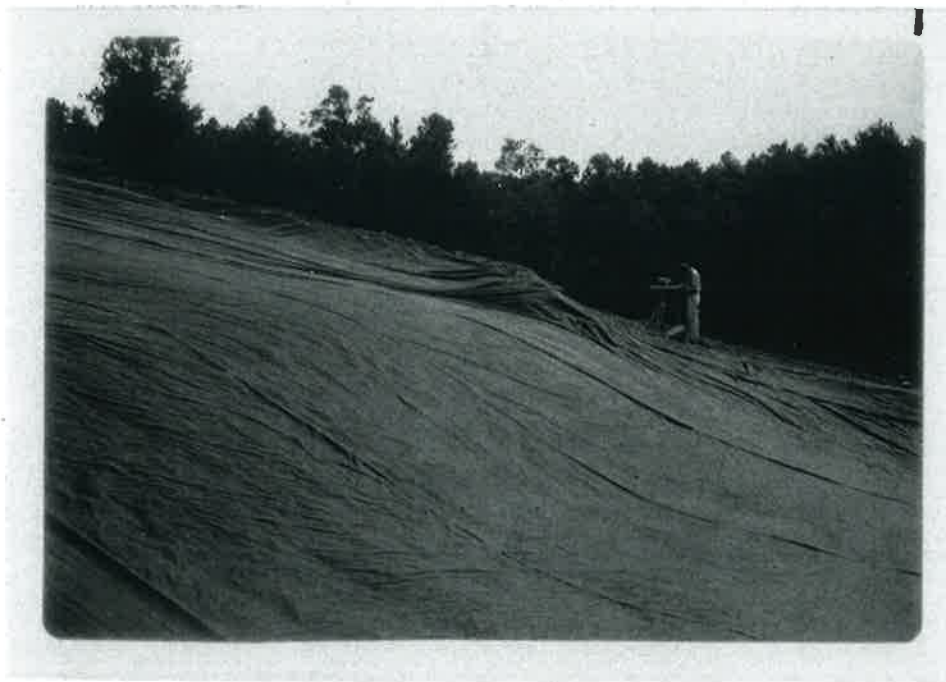
Figure 11. Another view of the pad just before spraying, looking toward the southwest.

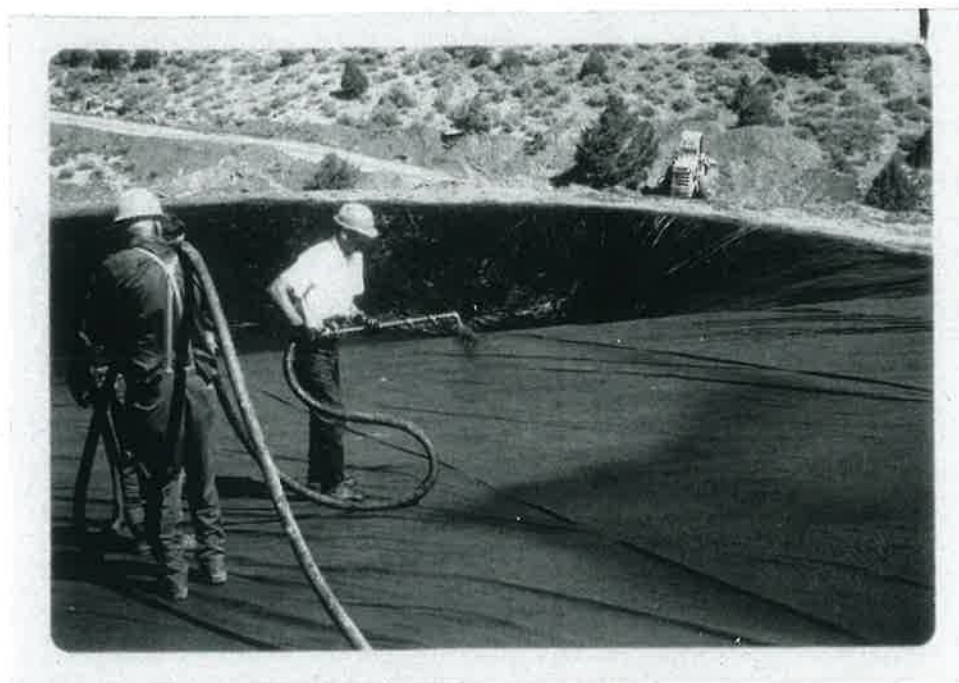
Figure 12. The asphalt was sprayed onto the pad as a brown water emulsion, which rapidly turned black as it dried. Three men were required to handle the hose. Occasionally the nozzles would plug due to the asbestos suspended in the asphalt; eventually we switched to a flattened piece of 3/4" pipe. Pressure for spraying was supplied by pressurizing the delivery truck.

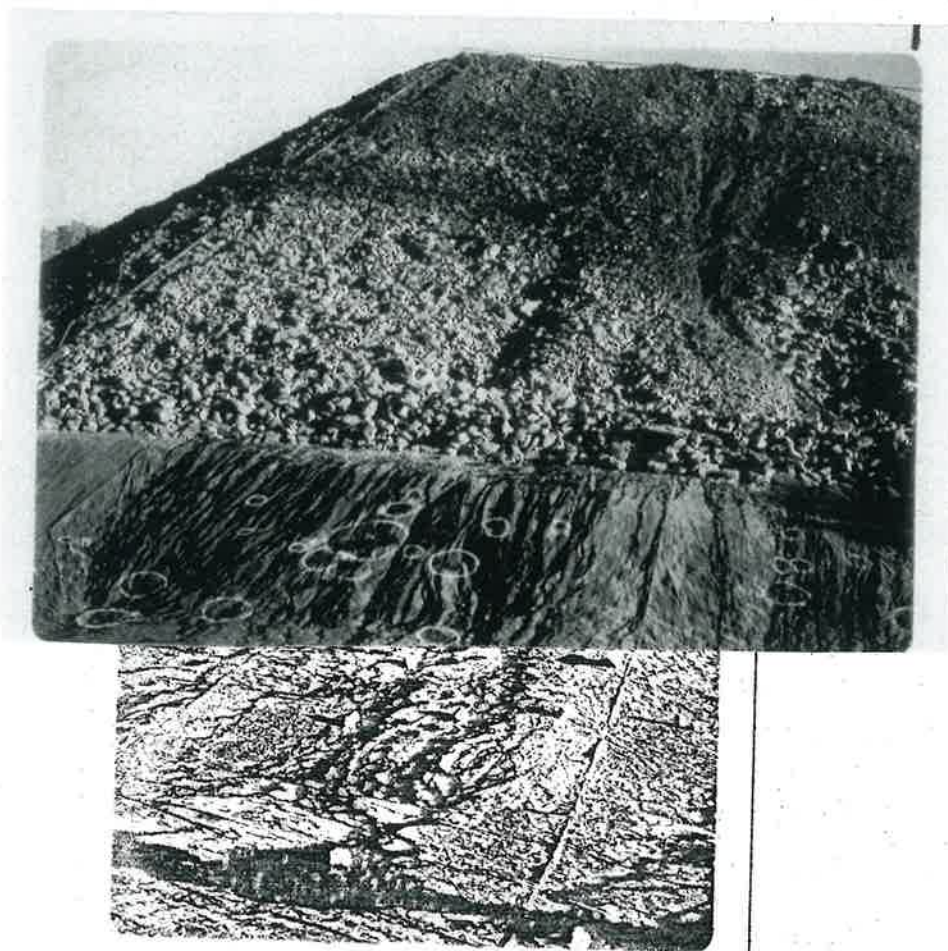
Figure 13 shows the pond after loading of the heap, during the week in which patching of the pond was being performed. White circles painted on the pad indicate the larger punctures. Rocks lying in the bottom of the pond in that view are six to eight inches in diameter, with sharp corners. These would commonly make five cuts 1/4 inch wide

Figure 13. Frontal view of the heap and pond after loading. White circles indicate cuts in the pad surface caused by rolling rocks. Drainage of leach solutions out the front toe of the heap has just begun. Also visible is the 2" header pipe running up the heap. The two lower rows of 1" distribution lines have not yet been installed.

as they rolled down the pad, and another five punctures 1/16 inch in diameter. Occasionally, rocks up to 18" diameter would roll down, and these would usually produce one or more cuts up to two inches long.

The method of repair recommended by Waterproofing Systems, Inc., is to coat the punctured area with Henry's Plastic Roofing Cement using a putty knife. If the hole is larger than 1/4", a small patch of the petromat fabric should be embedded in the cement. After this patch has been allowed a few days to form a crust, it should be coated with SS1h emulsion applied with a broom or rag.

After the 5000 ton heap was loaded, the obvious leaks in the pond (about 20) were patched, and the pond filled with water to the 8000 gallon level. Leakage of 3000 gallons occurred in 12 hours. A more careful search was then made, and during three search periods (interspersed with filling periods) an additional 60 leaks were found. It appeared that the major leakage was occurring under folds rather than through punctures.

Following the third filling cycle, the leakage had been reduced to 1500 gallons per 24 hours, and it was decided to carefully recoat the entire area with emulsion using a broom. While these procedures consumed nearly one week, actual repairs - including four hours to broom the new coating on an 1800 square foot area - took approximately 15 man-hours. Following the recoating, no leakage could be detected over a 3-day period.

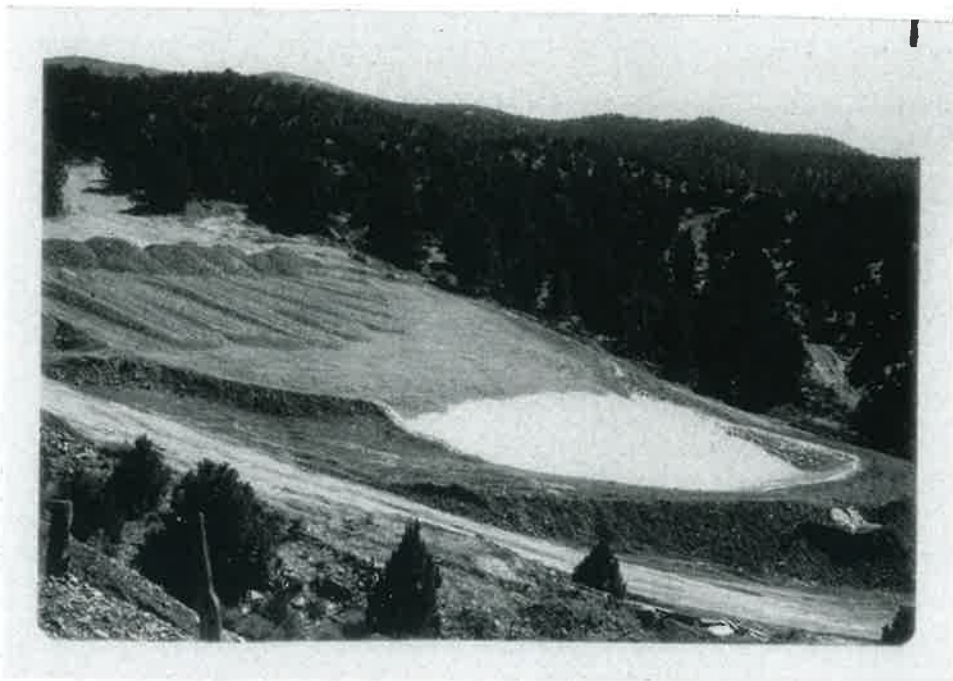
Figure 14. View showing the 5000 ton pad as the protective cover is being applied. The 2" gravel cover was placed by being dumped from an end-loader bucket and hand-raked. The 1-2 ft layer of 3-4" rock is being spread with a dozer. This view is taken from the same location as Figure 3.

On August 15 through 18, a 1 1/2 yard endloader and truck were leased, with operators, to haul 4-inch rock from a 30,000 ton stockpile of such material near the Big Pine Pit. As shown in Figure 14, this was dumped above the pads, and spread in a one to two foot thick layer by a D-7. In future operations, this layer should also be spread from an endloader bucket, to eliminate any possibility of gouging the pad.
